Port-au-Prince Earthquake Damage Assessment using Pictometry

A Report for ImageCAT Inc.

Cambridge Architectural Research Ltd
June 2010

Robin Spence, Keiko Saito, Cambridge Architectural Research Ltd
May 2010

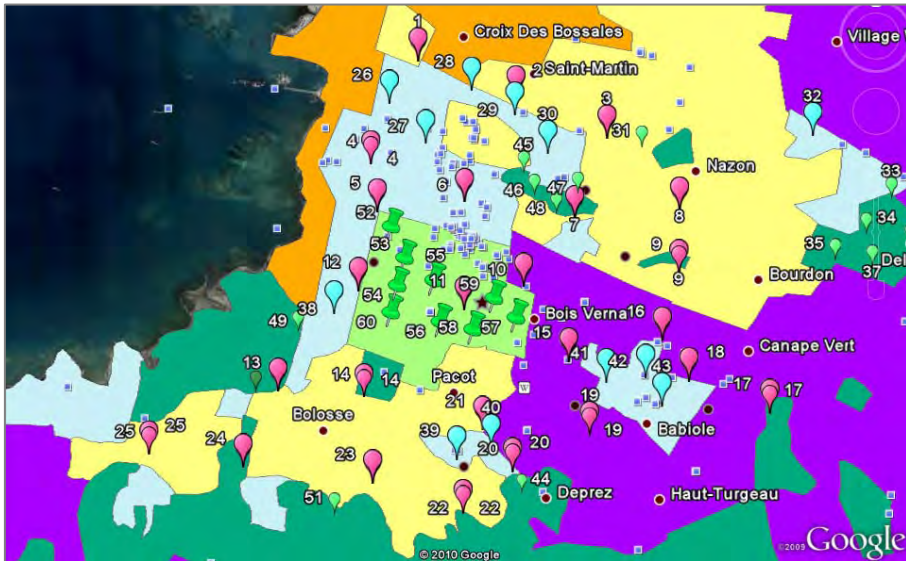
Figure 1 CAR's 60 damage assessment survey locations in Port-au-Prince, overlaid on ImageCAT landuse map

Since one of the main intended use of the field survey data was to assess the accuracy of the Pictometry damage assessment, it was decided during the planning of the mission that the field team should survey the same buildings on the ground as those included in the Pictometry data. Of the 60 pictometry survey locations indicated in Figure 1, 15 were chosen as candidate locations, using the parameters listed in the

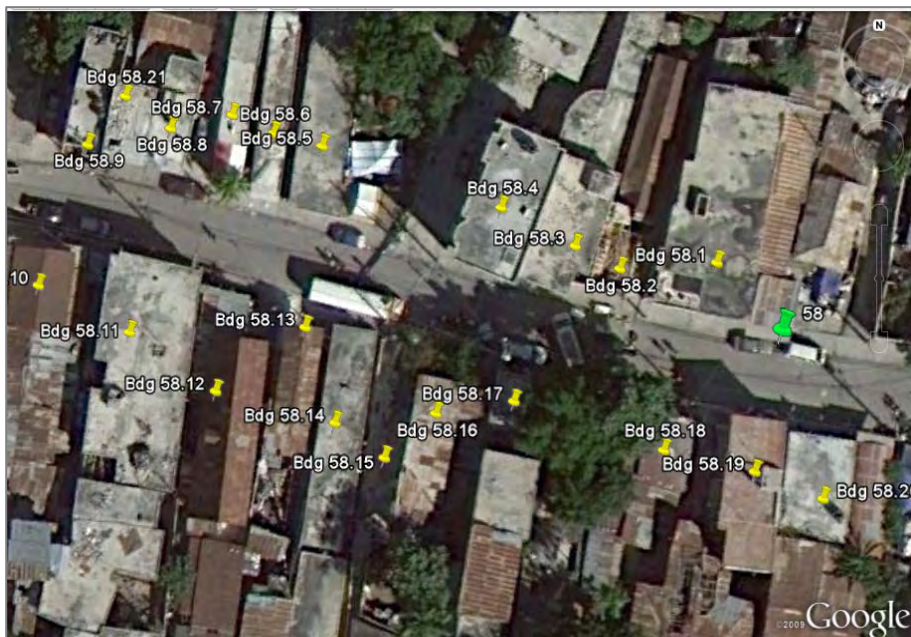
Figure 2 Building samples chosen at survey location 58 (Downtown area)

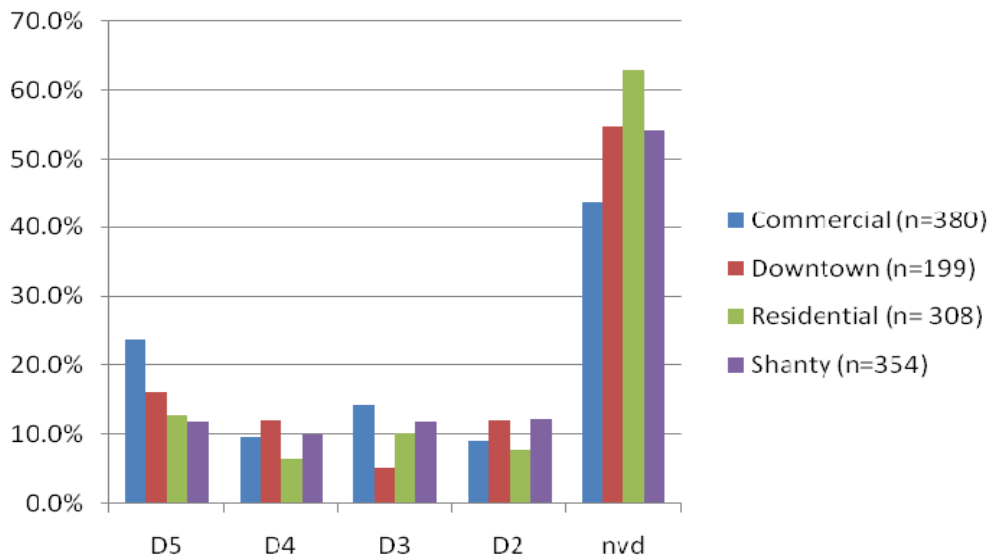
Figure 3. Damage distributions across 1241 buildings in PaP urban area from Pictometry survey, divided by land-use class.

The proportion of buildings in damage states D5 and D4 is not dissimilar across all four land-use classes. The highest damage rate (33.2% D4 or D5) was found in the commercial area; the downtown area (28.2%) was also comparatively badly damaged. Damage proportions in the residential and shanty areas were significantly lower (19.2% and 21.8% respectively).

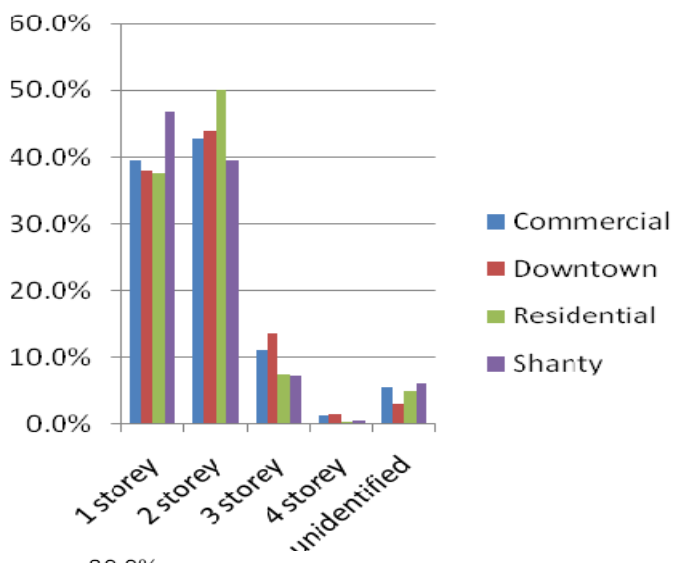
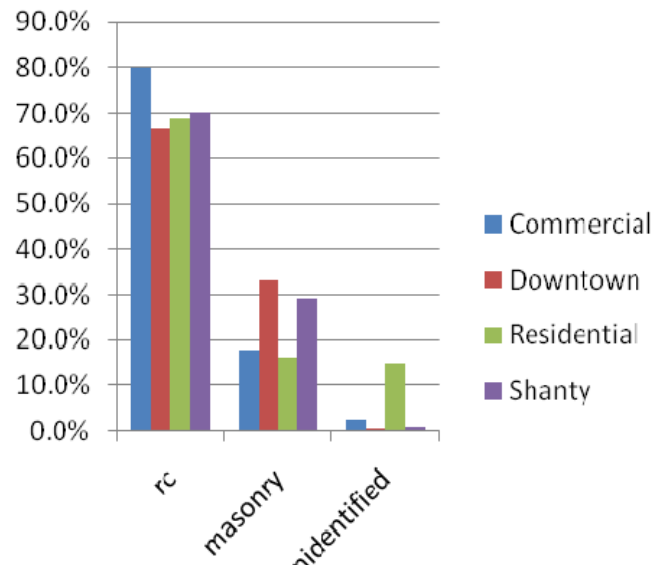
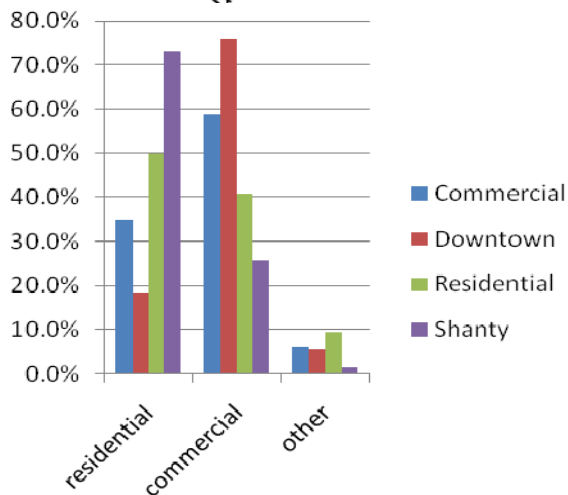
Results were surprisingly consistent across land-use classes. By storey height, numbers are fairly evenly divided between one and two storey buildings, with a very few 3 storey or higher buildings. By construction type, the vast majority (65% to 75%) of buildings appeared to be of reinforced concrete (rc) construction, with a rather higher proportion of non-rc (taken as masonry) buildings in the downtown and shanty areas. By occupancy, as expected the majority of buildings in the downtown and commercial districts were commercial, but a surprisingly high proportion of buildings even in the residential areas were identified as commercial. Mostly these were buildings with an apparent part-commercial function on the ground floor, which were identified as commercial; the numbers were probably inflated because the sampling of buildings tended to be along the more significant streets, to enable later comparison with ground-level photographic data.

(from top left) Figures 4, 5 and 6. Distribution of buildings across land use classes by number of stories, form of construction, and

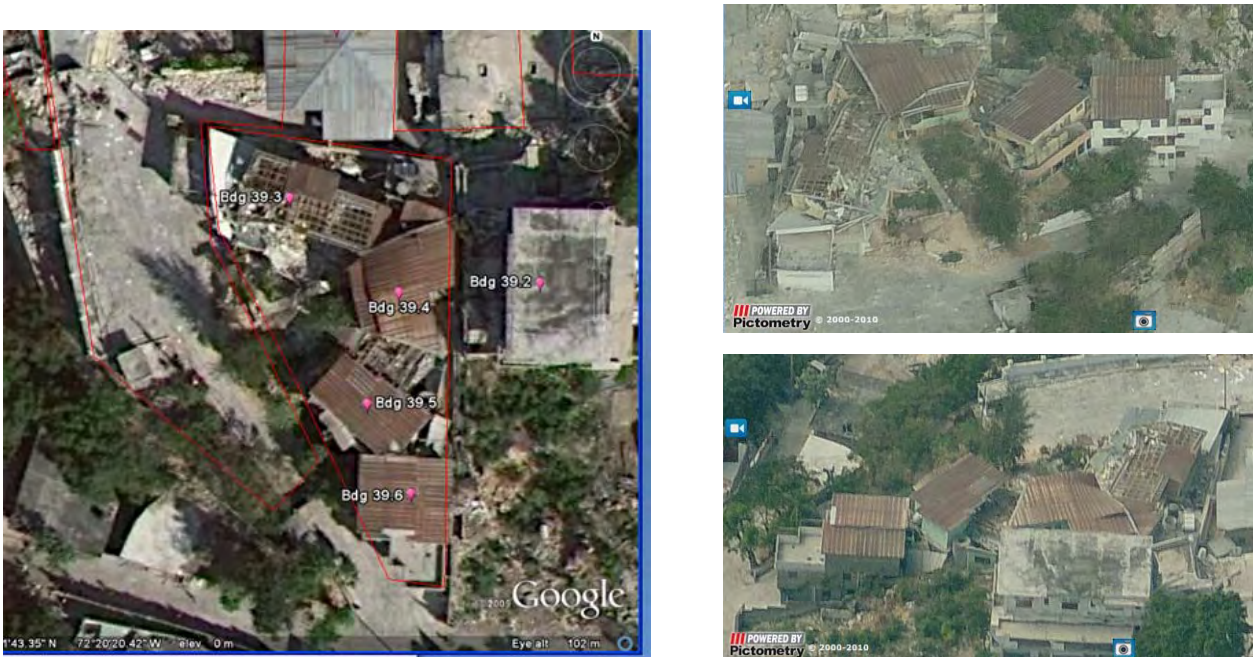
There are three main reasons for this type of discrepancy. The first type is when the GEO-CAN footprints were inaccurate, merging two or more buildings into one footprint. Figure 8 shows two examples where the GEO-CAN footprint includes more than one Pictometry building point. If the Pictometry building is smaller and the building is not damaged or assigned nvd, and the GEO-CAN footprint includes a building with D5, then the GEO-CAN footprint will be assigned D5. Half of the discrepancies where GEO-CAN=D5 and Pictometry=nvd (no visible damage) were of this type. When comparing the number of Pictometry building points that intersect with the GEO-CAN footprints against the number of intersecting GEO-CAN footprints, there are 253 GEO-CAN footprints that contain Pictometry building points, and within these footprints there are 292 Pictometry building points. This highlights the need for pre-defined building footprints that can be used for all damage assessments.

*Figure 8 (left) Four Pictometry buildings contained in one GEO-CAN building footprint drawn in red. Pictometry shows that Bdg 39.3 and Bdg 39.4 is one building. (Top right) Same four buildings seen in Pictometry from west to east, (bottom right) same set of buildings seen from east to west. *Note: in the GEO-CAN dataset dated 18th February 2010, the footprint for this building is smaller, with only Bdg 39.3 delineated as D5. The analysis carried out for this report is based on a GEO-CAN dataset dated 24th February 2010, which is shown in figure 8 above.*

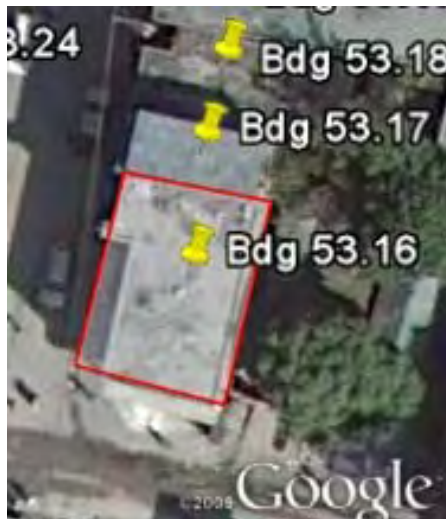
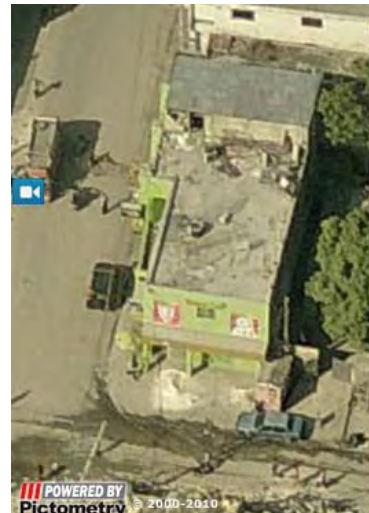
Most of the reasons listed above for GEO-CAN=D5/Pictometry= less than D3 also apply here. In addition, there is a tendency in the GEO-CAN damage assessment where if there is collateral damage from neighbouring buildings and/or rubble (or objects resembling rubble) is visible on the roof, the building is classified as D4 in GEO-CAN. Similar to these collateral damages, if there is material (e.g. timber) visible in the back yard or on roof tops, these buildings are likely to be classified as D4 in GEO-CAN. In developing countries, it is quite common to see materials on the roofs of buildings as seen in figure 9 below, which makes it difficult to assess whether the building is damaged or not.

Figure 9 An example of a building that was classified as D4 in GEO-CAN(left) but nvd (no visible damage) in Pictometry. The objects seen on the rooftop give the impression of damage to the roof/building.

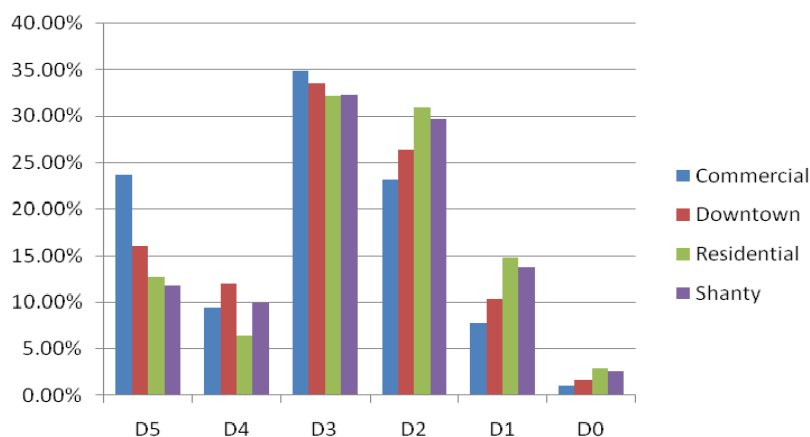
and D3. The proportions at damage level D4 and D5 are assumed to be as observed. This process leads to the overall damage distributions shown in Figure 7 and Table 7.

Figure 7 Estimated overall damage distributions assuming binomial distribution governs lower damage levels

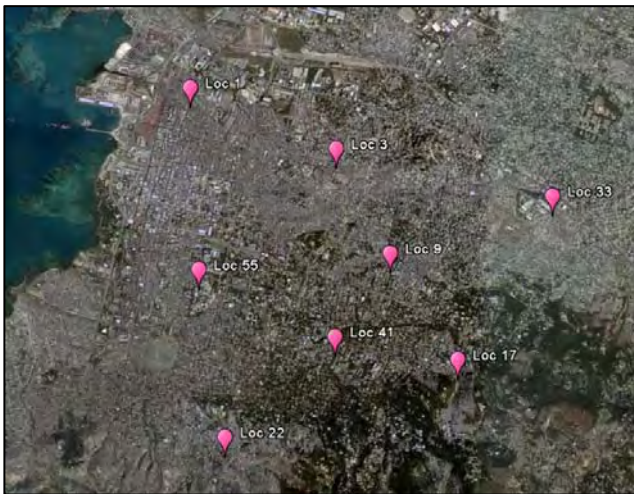
Figure 8 The eight locations visited in Port au Prince, Haiti, by the EEFIT team to carry out a systematic building survey. The number of buildings surveyed in each location varied between 10 to 20 buildings, with the exception of location 41 where 42 buildings were surveyed.

headings of the columns in Table 8, making sure to select locations with diverse characteristics. Of the 15 locations, the EEFIT team was able to visit 8 locations in the 3.5 days that was spent doing the building surveys, and in total 124 buildings were surveyed in Port au Prince. Table 8 shows the characteristics of the 8 locations visited, figure 8 shows the 8 locations in Google earth.

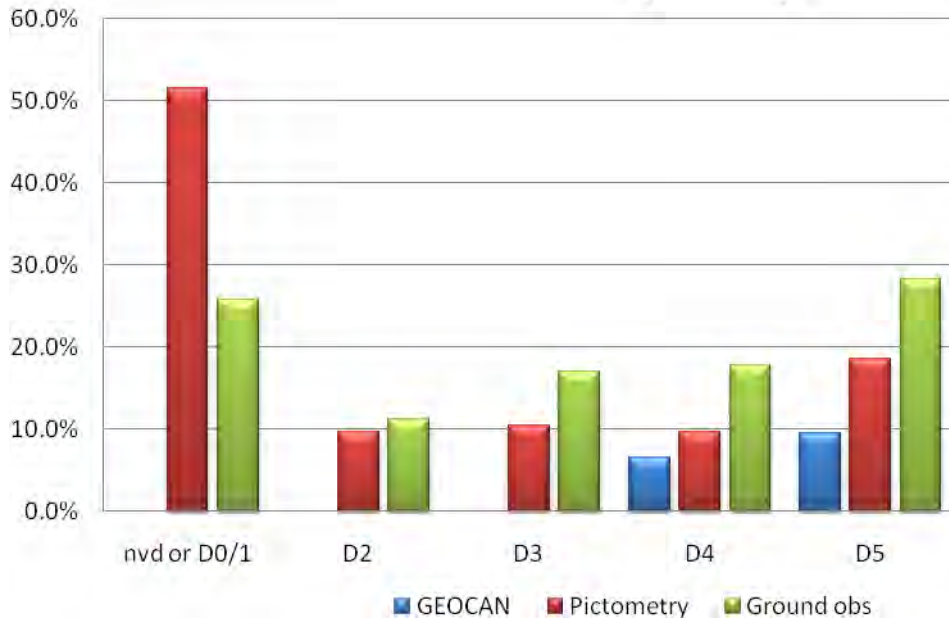
Figure 9. Comparison of GEO-CAN, Pictometry damage assessment and EEFIT ground survey results. N=124.

The differences between the three approaches in the proportions of buildings at damage levels D4 and D5 are striking. Among the 124 buildings included in the ground observation survey, the observed proportions at damage level D4 and D5 were 18% and 28% respectively. The proportions seen in the Pictometry survey were 10% and 19% at D4 and D5, ie only 63% of the actually observed number, while those observed through the GEOCAN study were 7% and 10% at D4 and D5, ie only 40% of the actually observed number.

Another notable difference between the Pictometry and ground observation results is seen in class *nvd or D0/1*. The difference is almost two fold. This can be explained by the fact that *nvd* (Pictometry) includes the buildings where the view was obscured due to trees or other factors, as well as the true *D0/1*s. Table 9 shows the breakdown of the number of buildings assigned *nvd* in Pictometry that was assigned a damage level of more than D2 on the ground by the EEFIT team.

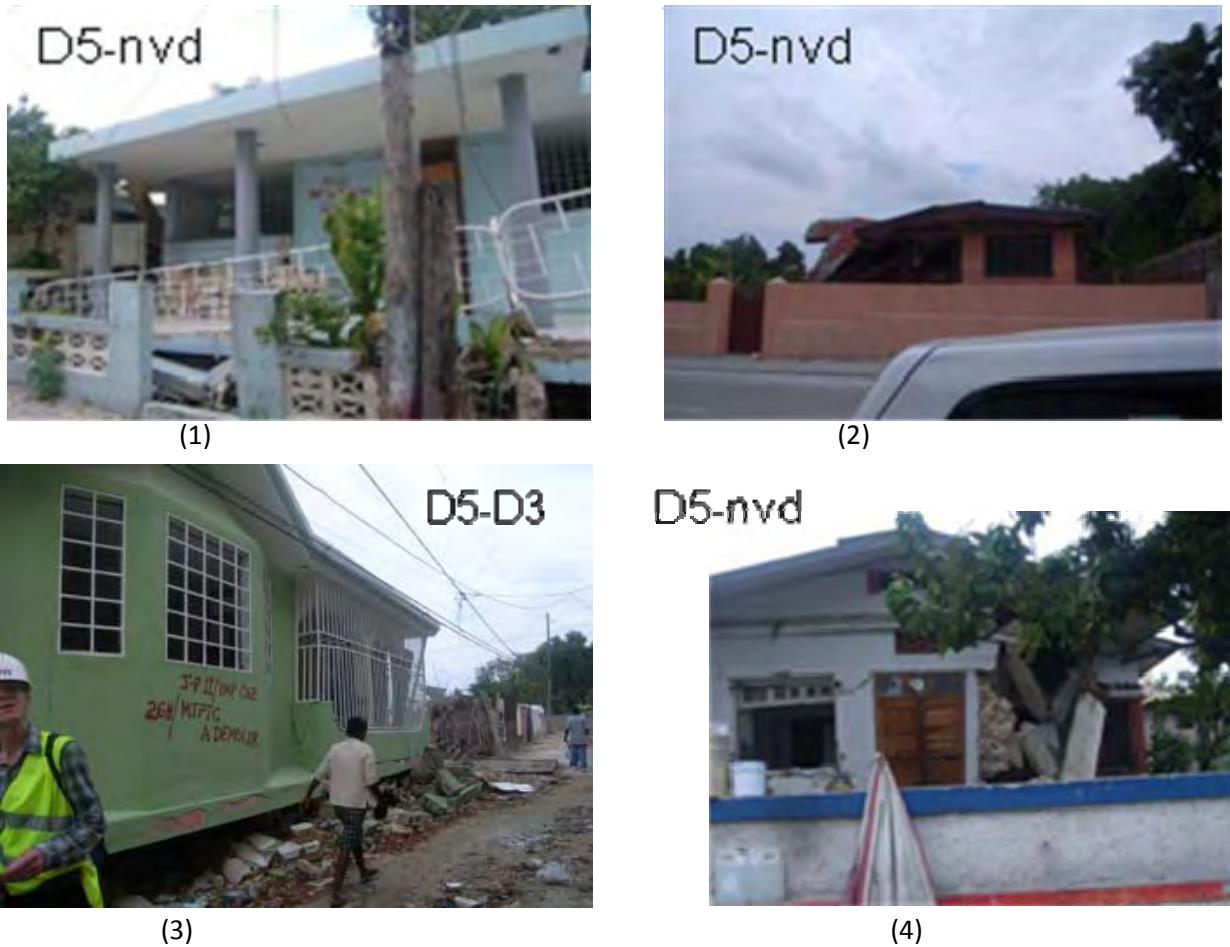
Figure 10. Examples of D5 (EEFIT) – nvd or D3 in Pictometry

These buildings were assigned D5 by the ground survey, whereas in the Pictometry survey they were assigned either nvd or D3, and represent the largest discrepancies. Pictures (1) and (3) show soft-storey collapses typically seen in a residential area. Picture (2) shows a building where one of the columns has been damaged, causing one corner of the roof to fall. The building in picture (4) has partial collapse where one of the corners, including a column, has completely failed. The tree in front obscured the view in Pictometry, hiding the failed section of the building. The view of buildings (1) and (3) in Pictometry is shown in Figure 11.

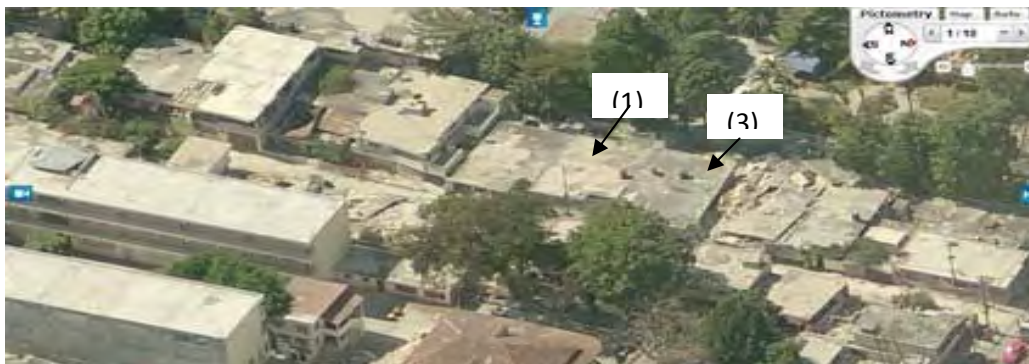
Figure 11 Buildings (1) and (3) in Figure 10 as seen in Pictometry.

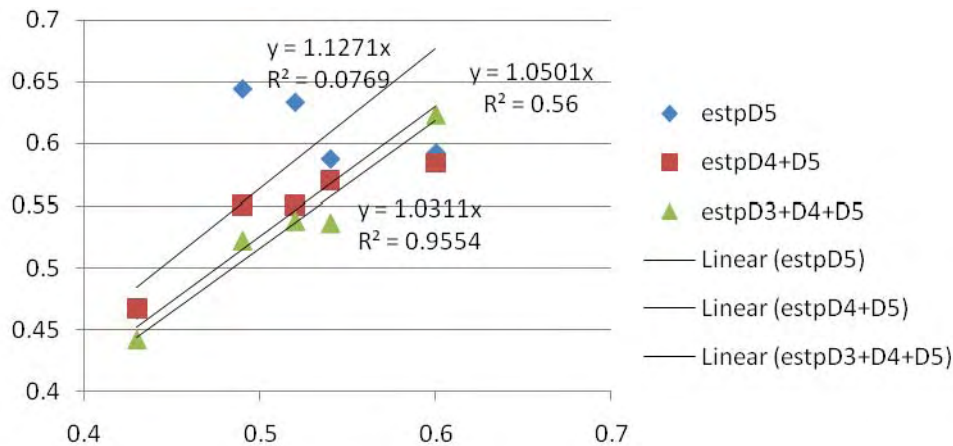
Fig 1 shows that the estimate using D5 only is poor; it is in error on average by 12.7%, and the regression coefficient (R^2) of estimated p on actual p is less than 10%. When the D4 data is added in, the estimate improves greatly; the average error is 5%, and R^2 increases to 56%. When D3 data is added, the estimate becomes good; the average error is only 3%, and R^2 increases to 95%.

Figure A1. Estimates of binomial parameter p plotted against “true” binomial parameter for 5 damage datasets derived from surveys after the 1997 Umbria Marche earthquake (Dolce et al 1999)
